**NEW AND REMANUFACTURED BRAKE  
SHOES WITH PLATINUMSHIELD™ II  
COATING FOR THE AFTERMARKET**

# THE POWER OF PLATINUM CONQUERS RUST-JACKING. AGAIN.

**“Brake-Through” Technology Solves The Industry’s Rust-Jacking Problem!**

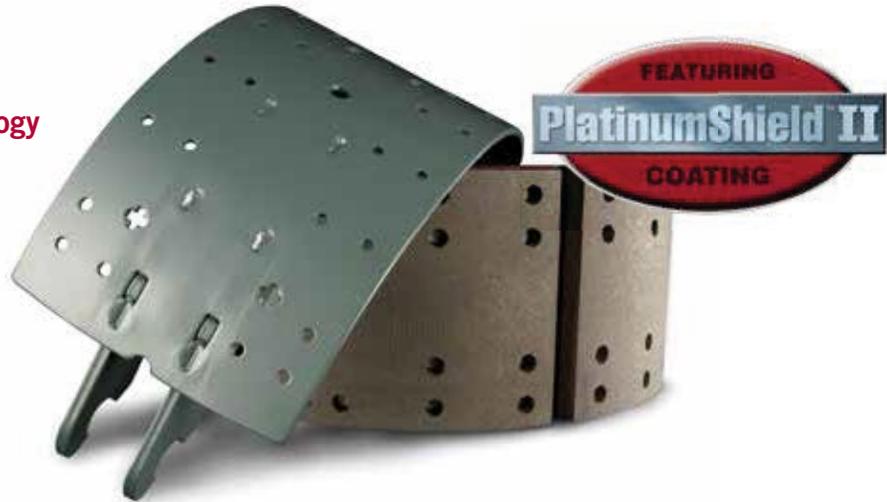
PlatinumShield™ II coating. It’s one very big Meritor idea that results in even bigger dividends for you and the whole trucking industry.

Why? Because Meritor® new and reman brake shoes with PlatinumShield II – the second-generation brake shoe coating that features a stronger formula – provide unsurpassed resistance to rust-jacking and corrosion while extending the life of your brakes.

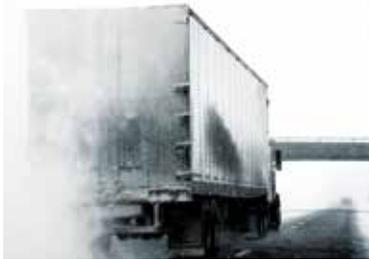
■ “Rust-jacking” is a field condition caused by corrosive anti-icing highway chemicals – combined with thawing and freezing moisture that penetrates the brake shoe coating and causes rust to build up on the brake shoe table.

■ As rust builds up, it pushes outward against the lining, “jacking” it up between the rivets, until the lining cracks.

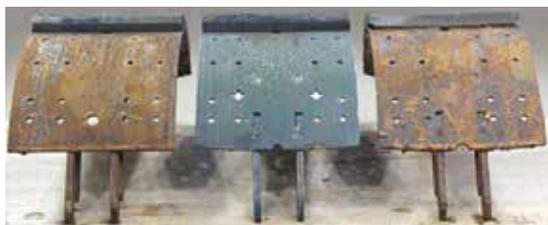
Results after salt spray test.  
(Left) PlatinumShield II coating; (right) Competitor G.

Next, in our ASTM B-117 Salt Spray Test, brake shoes were sprayed with a bath made of modern anti-icing road solvents and salt water for 408 hours. We observed how rust forms on brake shoe tables and tested the corrosion resistance of countless paints and coatings.

Of all the brake shoes and coatings tested, we found that PlatinumShield II does the best job of protecting the shoe table by preventing micro-abrasions, so rust-jacking simply does not occur during the expected life of the brake shoe. In fact, the PlatinumShield II coating meets our list of desired criteria:
